**NRO**  
**INVENTORY**

National Park Service  
Pacific Northwest Region  
Cultural Resources Division

North Mowich Trail Shelter

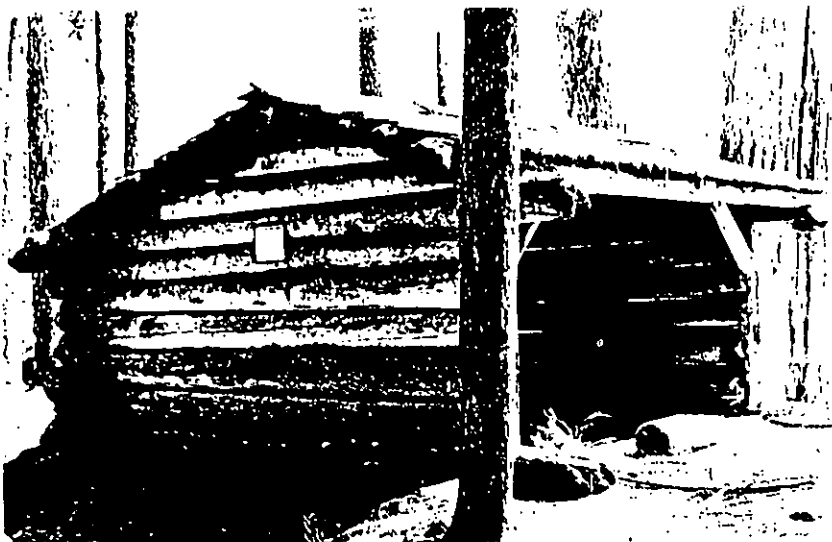
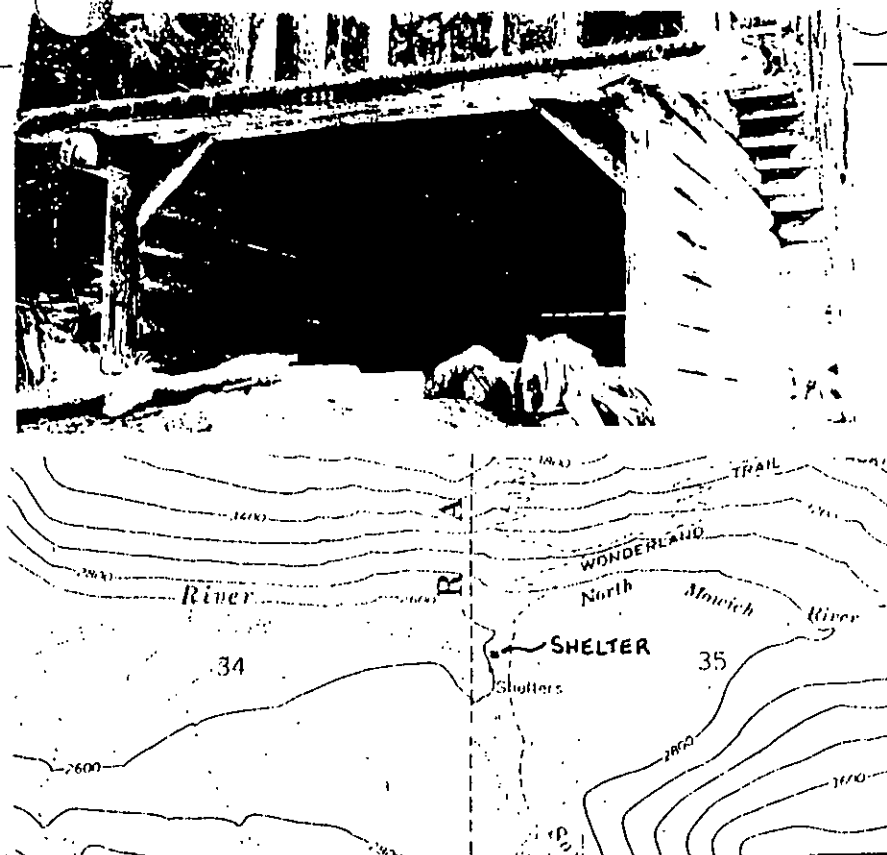
17. PHOTOS AND SKETCH MAP OF LOCATION

Log frame, one-room, one-story, square plan trail shelter; "saltbox" (lean-to) design; cedar shake roof over projecting whole log purlins; open front facade; whole log walls; post, beam, and bracket supports at front corners; rear corner saddle notching; log sill foundation; unfinished interior; 1-1/2 x 6 tongue and groove floor.

A 1924 map of Mount Rainier National Park shows a trail shelter between the North and South Forks of the Mowich River. The structure is no longer extant. This trail shelter, built in 1934 by the CCC (Thompson, 1981), is located on the Wonderland Trail on the north bank of the North Mowich River. Two other shelters constructed more recently are in the vicinity of this shelter. The supervisory landscape architect said, "It is a model of good log construction" (Thompson 1981:17). The shelter measures 14' x 14', with a floor size of 210 square feet. Floor to ridge beam is eight feet. The open front facade is 6'4" x 14'. Structural condition is one of deterioration. There is excessive log rot, especially on the projecting log ends at the corners. There is need for new base logs, especially on the east (rear) and north facades. The interior is very dirty. The wood floor has numerous holes, and there is need for a new roof.

☒ DETERIORATED
